Inspection & Maintenance Guide

Keys for Trouble-Free Operation of Wrap System

QRCKK69754 (06OCT21)
Printed in U.S.A.

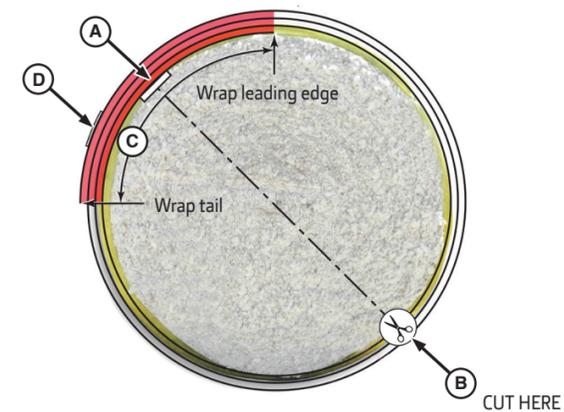
1. An average size module is between 228 cm (90 in) and 238 cm (94 in).
2. An RFID tag (A) is located near the inner wrap end (usually it is not seen).
3. The safe cutting zone (B) is 180° from the RFID tag location.

NOTE: The red zone (C) is a “No Cut Zone”. Cutting in this area may cause small pieces of wrap to enter into the cotton.

4. If the wrap removal machine does not have an RFID reader, the safe cutting zone (B) should be 180° from the white metallic label (D) with barcode and serial number located 39 cm (15-1/2 in) above the wrap tail (visually seen).

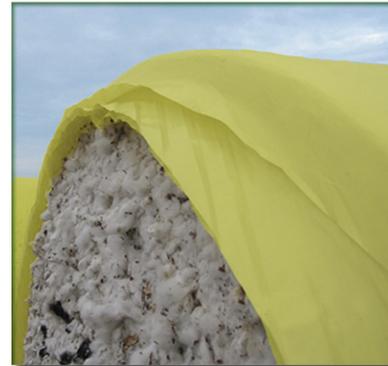
Loose Cover-Edge

- Check for debris in the slots of the wrap box side sheets.
- Inspect wrap box and wrap roll mechanism and clean as necessary.
- Ensure that wrap is being adequately tensioned. Wrap speed should be approximately 233 rpm during feeding, slowing to approximately 100 rpm during separation. This can be monitored on the armrest display in the cab.

If speeds HIGHER than 233 rpm are observed, check for wrap clutch malfunction.

- Check for slippage between the armature plate and the coil on the pulley.

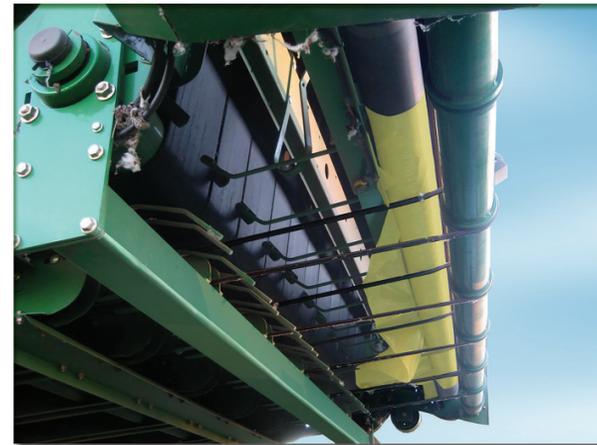
Wrapped Rubber Roller

Non-tacky next to rubber	Tacky next to rubber
<p>This suggests that the leading edge may not have fed into the chamber, bunching up on the wrap floor belts until the rubber roll grabbed it and pulled the bunched up material backward onto the roll.</p>	<p>This suggests that the non-tacky section fed in, and there was a failure in the tacky section that caused it to break in two during feeding.</p>
Potential causes:	Potential causes:
<ul style="list-style-type: none"> • Obstruction at the lower gate roller. Wrap could not enter the chamber. • Adhesive deposit on the rubber roller. Remove roller and inspect. Clean with acetone if deposits are found, using appropriate personal protective equipment. If acetone is not available, "neutralize" with dust/dirt until it can be cleaned later. • Wrap core is tight between wrap supports. Wrap does not feed into bale chamber before the wrap floor retracts. If a tight core is found, cut the end of the core to allow the core to turn freely. 	<ul style="list-style-type: none"> • Joint between the non-tacky section and the tacky section failed. • Crosswise tear during feeding. Potential material issue. Report to your John Deere dealer.

When removing wrapped material from the bottom roller, pay attention to which material is closest to the rubber: non-tacky or tacky.

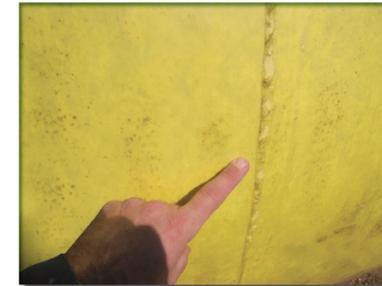
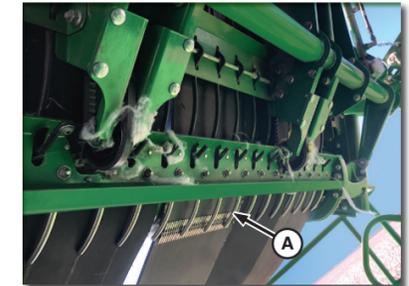
Intermittent Damage to the Tacky Wrap

- Bent finger on the lower guide rod is contacting the baler belt. There should be 3 mm (1/8 in) to 6 mm (1/4 in) of clearance between fingers (A) and the baler belts. The easiest way to check is in the RMB Service Setup Mode with the gate in cradle.
- **Hint:** Notice that the spacing between the tears is equal to the spacing between the fingers. This can help determine the source of the damage.

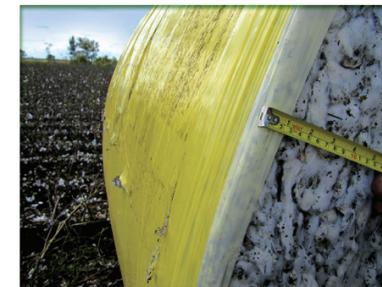
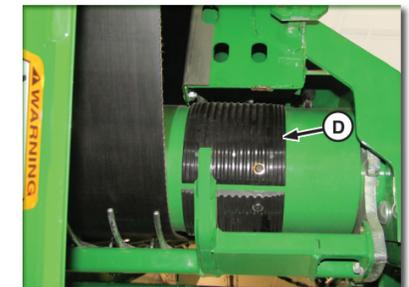
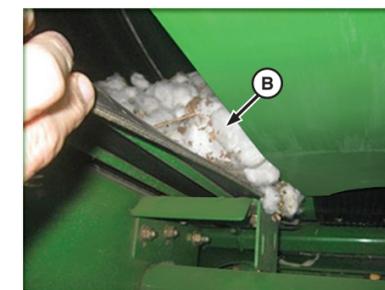
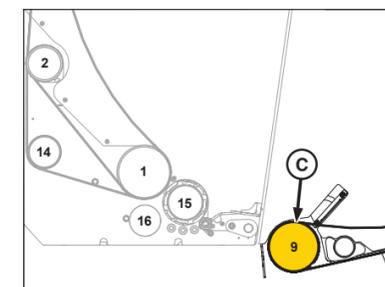
Inadequate or No Cover-Edge

- Cotton buildup (B) inside the baler belts behind the lower gate roller (C). This is often the result of excessive gap between the side wall and outer belt. Refer to page 4 for inspection and adjustment.
- Debris in wrap feeding area. Verify that wrap floor and fingers are clean.
- Improper gate position. Verify that turnbuckles at the top of the baler are set correctly and that the lock nuts are tight.
- Wear of plastic guides (D) on the lower gate roller (C). Replace guides if worn.

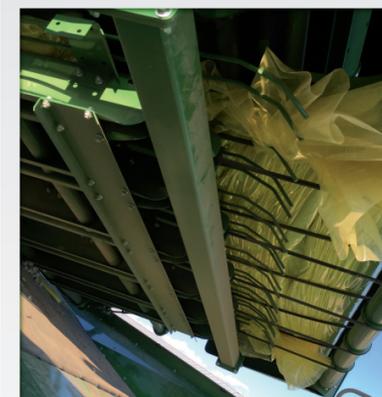
Wrap Bunching on Floor

- Leading edge of wrap did not feed into the chamber, resulting in accumulation on wrap floor.
- Check for obstruction at lower gate roller.
- Verify that wrap feeding area components (guide rods) are set correctly. Bend rods as necessary to maintain 3 mm (1/8 in) to 6 mm (1/4 in) clearance between the tip of the rods and the baler belts.

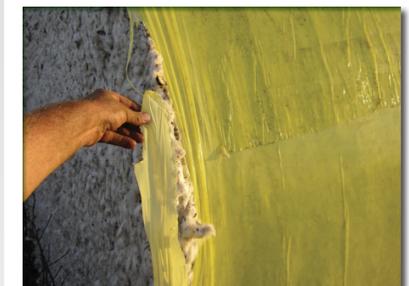
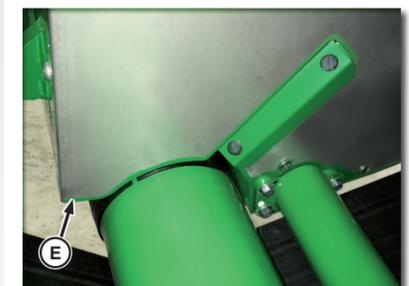
Edge Tear

- Excessive gap between outer belts and RMB wall. Adjust gap as described on page 4 of this guide.
- Damage to baler interior side sheet (E). Stainless steel panel should be smooth and free of dents or bends.

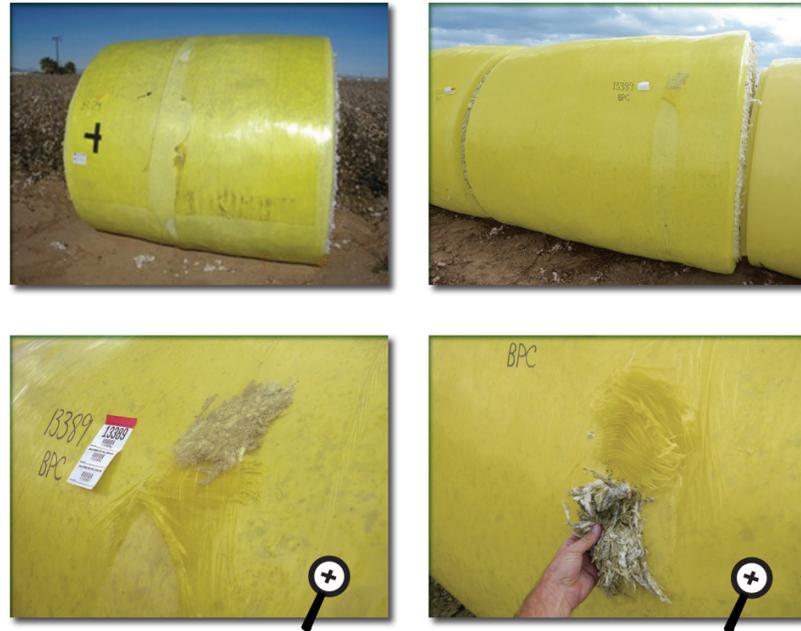
- A damaged or twisted belt in the baler. Inspect bale chamber.
- The photos to the right show the result of a "wad" of cotton getting lodged in the lower guide rod during wrap feeding and eventually feeding in with the wrap. This wad of cotton likely ended up on the wrap floor after cleaning the machine. A good practice after cleaning the machine is to verify that the wrap floor and the leader of the next wrap portion are free of debris.

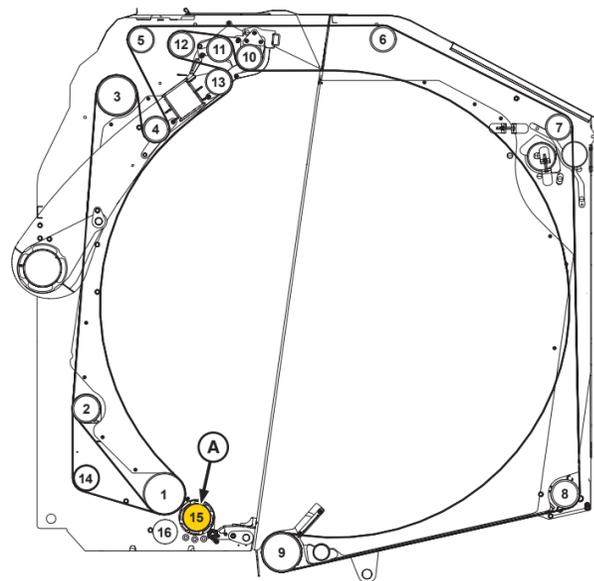
Unwrapped Module Ejected - Wrapping of the Starter Roll

- Wrap feeds into the chamber, but it wraps around the starter roll (roll 15 shown below in yellow) and winds up on it instead of wrapping around the module.

- Bunching of the wrap or uneven feeding increases the chance of this happening. Inspect the wrap floor for debris or incorrect guide rod clearance.

NOTE: A good practice is to do a quick visual check of the wrap slot via the remote camera before ejecting the module. If wrap is not observed in the wrap slot after wrap feeding process is complete, this indicates that the wrap has gone around the starter roll.

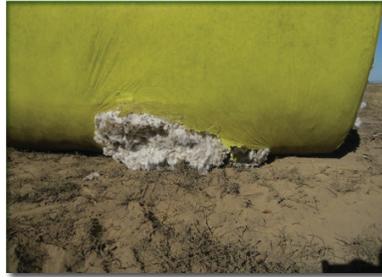
- Turning tractor before forks pulled away from module.

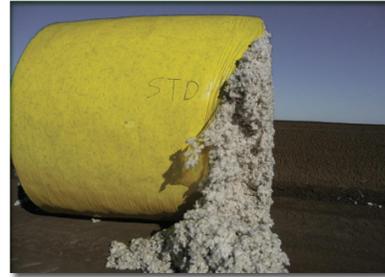
- Turning machine or raising handler before handler is away from module.

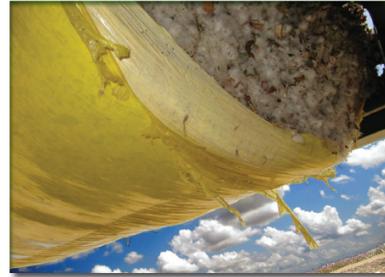
- Bottom drag on the stalks.

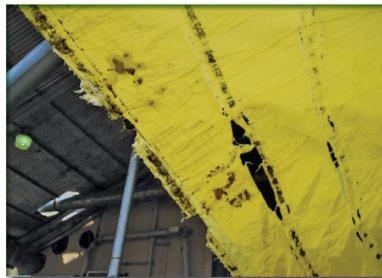
- Damage if inappropriate chains are used (see figures below) or if chains are run after load reaches front of truck.

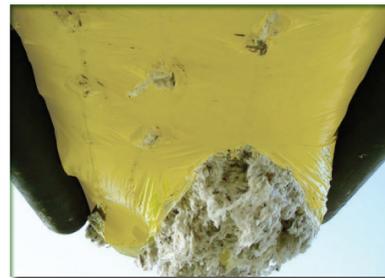
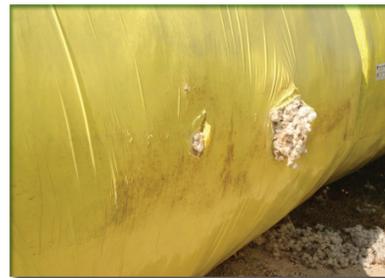
- Damage from the module truck side wall during load/unload.

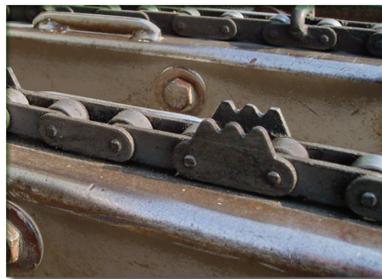
- High potential to damage wrap.

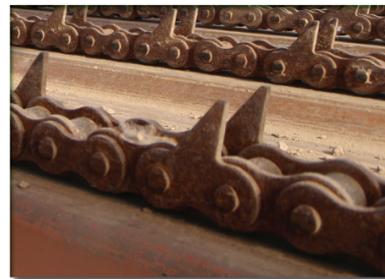
- High potential to damage wrap.

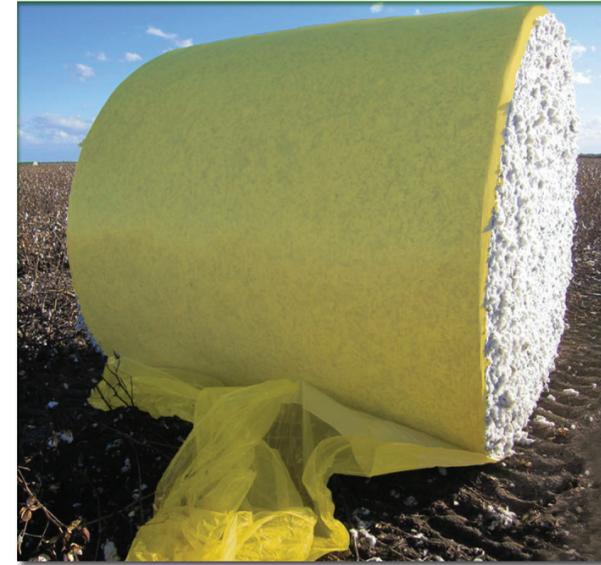
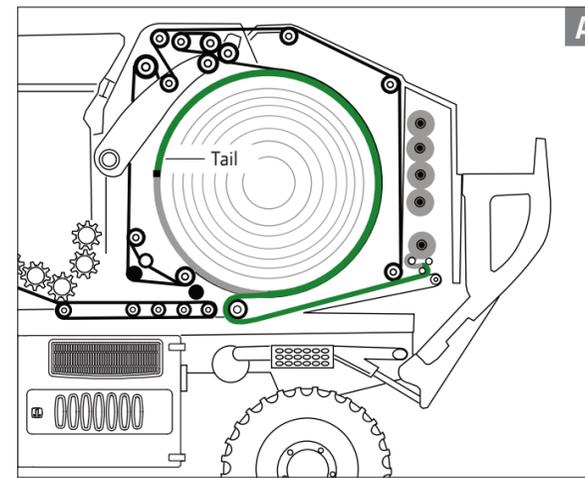
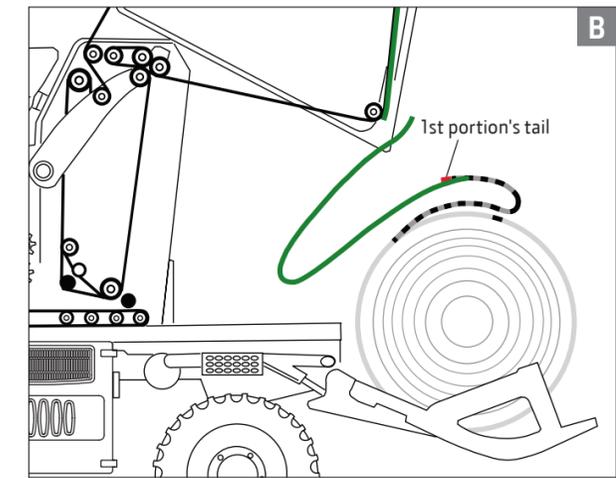
Partially Wrapped Module or Wrap Trailing out of Gate after Ejection

- Wrap does not separate and pulls in another portion. Upon ejection, when the round module rolls down the ramp, it unrolls the wrap that is on the module.

- Most likely cause is that the clutch armature becomes seized and does not stop the wrap feeding when the separation tag passes the IR sensor. Refer to page 5 for information concerning the clutch.

- After Z-lock separation, the baler rotates the module in the chamber in order to get correct tail orientation after the module is ejected. This means that the tail is towards the front side of the module (nearest the cab) before it is ejected (see figure A). If Z-lock separation does not occur, the baler will pull in approximately 5 m (15 ft) of the next portion. When the module is ejected, it rotates approximately 180° from its position in the chamber to its position on the ground. As the module rolls down the ramp and handler, it unwinds the 5 m (15 ft), and continues to unwind the tacky section of the first portion (see figures B and C).

Potential risk: Loose tails can cause contamination of material.

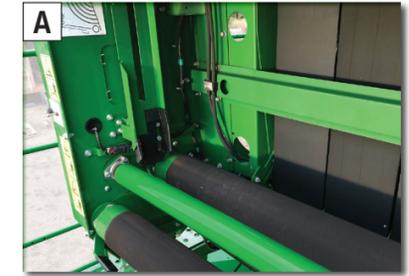
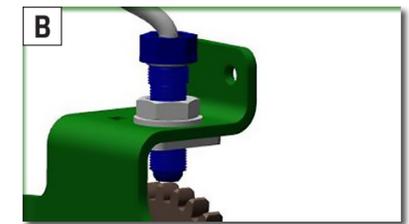
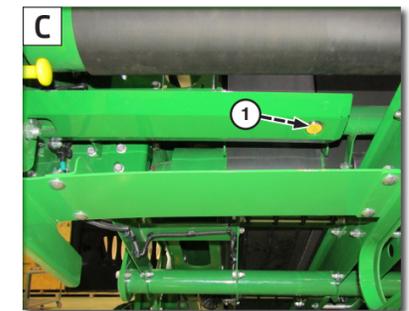
Multiple Wraps on Module with Normal Z-Lock Separation on Outer Portion

- Separation label not present or comes off and adheres to the wrap rolls.
 - If found on roller (figure A), remove and clean with acetone, utilizing appropriate personal protective equipment (PPE).

- Proper Z-lock separation relies on quick response of the clutch to stop feeding the wrap when the separation label is seen. This is accomplished by the armature plate shifting from the pulley-mounted coil to the fixed coil. If the armature plate does not slide freely, separation is delayed and some of the next wrap portion may be fed into the chamber. Contact your John Deere dealer for service.

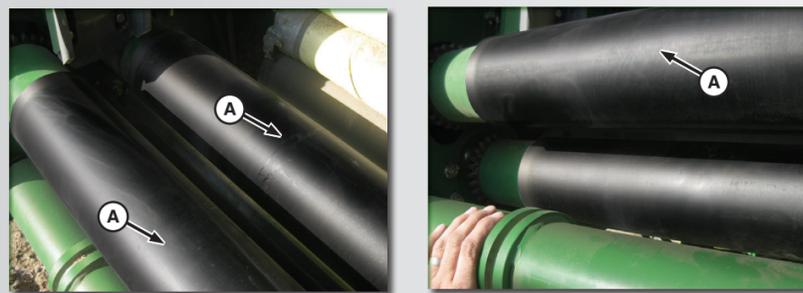
Adhesive Deposit on the Rubber Rollers

- Possible adhesive from the separation label or RFID label (A).
- Adhesive from the tail.
